ANALYSIS OF THE BMA K2400 VERTICAL CENTRIFUGE TURBINE IN TERMS OF BALANCING AND VIBRATION DIAGNOSTICS

МИКОЛАЙ ШИЦА, ЯНУШ МУСЯЛ
Науково -технічний університет УТР, Бидгощ, Польща

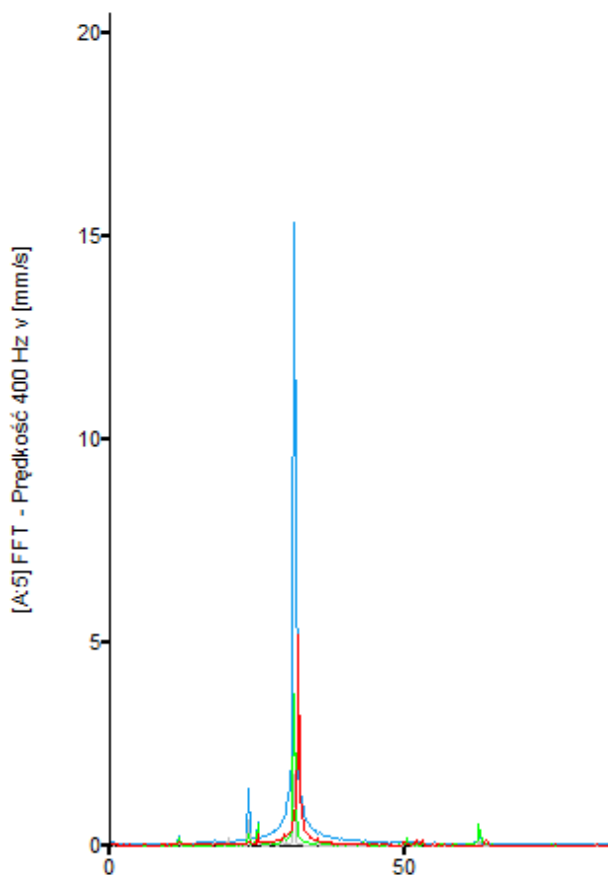
Fig. 4. FFT spectrum of the vibration velocity at the bearing node No. 1 in the radial direction X

an increased value of the RMS parameter of vibration velocity, with the simultaneous lack of anomalies in relation to the AVG and Peak parameters of the vibration acceleration envelope, the assumption about the machine's unbalance may be confirmed.

In relation to the FFT velocity spectra, can be observed a three times higher amplitude value at the rotational frequency of 31.25 Hz compared to the highest value so far measured, as described by Dwojak and Rzepiela in [1], this may suggest an unbalance of the machine. The experience with rotating machines to date suggests that in the case of

In relation to the above diagnosis, the test was carried out single plane balancing. Due to the nature of the

centrifuge load by the belt transmission, it was decided to perform a single-plane balancing in the radial direction Y.

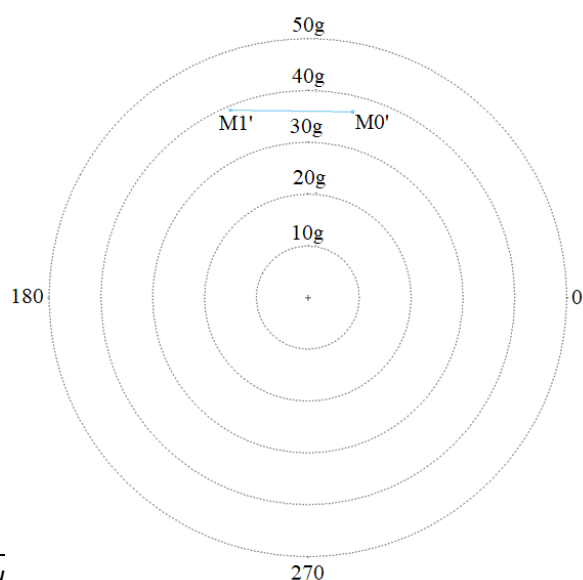
Fig. 5. Correction mass values for the first balancing

Fig. 5 and Table 3 present the course of one of the centrifuge balancing tests, which turned out to be ineffective as a consequence of the absolute lack of effects when adding mass at phase angles indicated by the operated measuring device. An important fact is that the centrifuges in a given engine room, as a rule, have been balanced so far on a single plane, due to the difficulties in correcting the mass of the pulley, which could constitute the opposite plane.

As a consequence of the impossibility of balancing the centrifuge, with the vibration level assessed as unacceptable, it was recommended to inspect the centrifuge with particular emphasis on the centrifuge bearings and vibration isolators of the centrifuge.

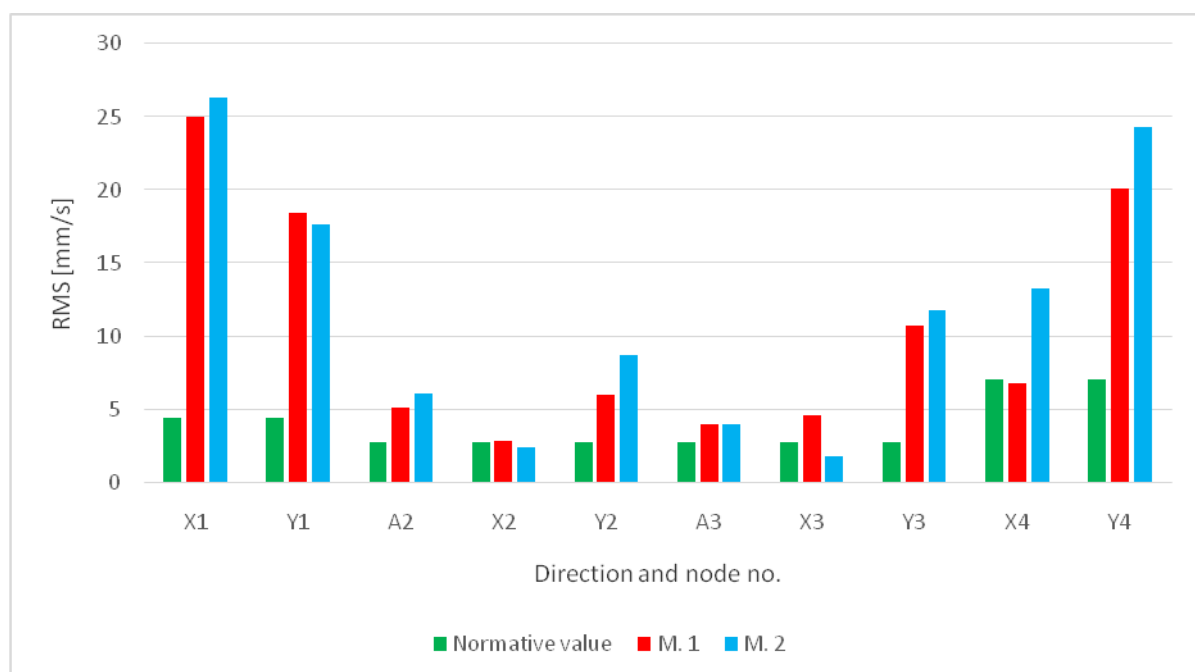
Fig. 6. Compare the normative values of RMS velocity with measured in measurements no. 1 and 2

Fig 6. shows the ratio of the RMS velocity values from Tables 2 and 4 to the normative values presented in Table 1. As can be seen, the velocity parameter values did not change significantly by replacing the motor bearings. Comparing the results from Tables 2 and 4, however, an increase in the Peak and AVG parameters of the envelope of vibration acceleration in bearing nodes 1 and 2 can be observed. suggest accelerated wear of the bearings.

As a result of the lack of effects after replacing the motor bearings and after analyzing the vibration measurement results presented in Fig. 6, a decision was made to inspect the centrifuge bearings. The diagnostics was performed again, but it concerned only the bearing node No. 1 with the disassembled basket. The diagnostic results are presented in Table 5. This allowed for a preliminary diagnosis of the reason for the impossibility of balancing the centrifuge. The NU315 ECP / C3 bearing, despite being brand new, was damaged during the first measurement, which most likely resulted from a technological defect of the outer ring of the bearing. The pitting with dimensions of approximately 20 mm x 5 mm is presented in Fig. 8.

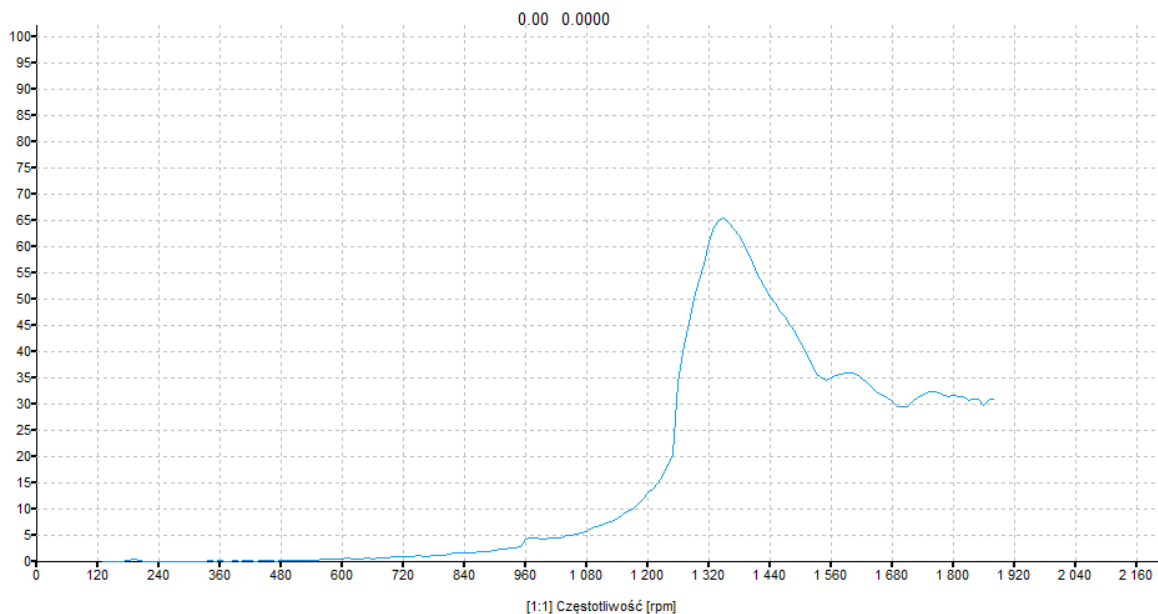
Fig. 7. Velocity values in the freewheel diagram in the Y direction

In order to rule out problems with the machine's vibration isolation, a run-up chart was made, which was suggested by Zachwieja [15]. As can be seen in Fig. 7, the centrifuge, operating at 100% efficiency, does not operate at the critical / resonant frequency.

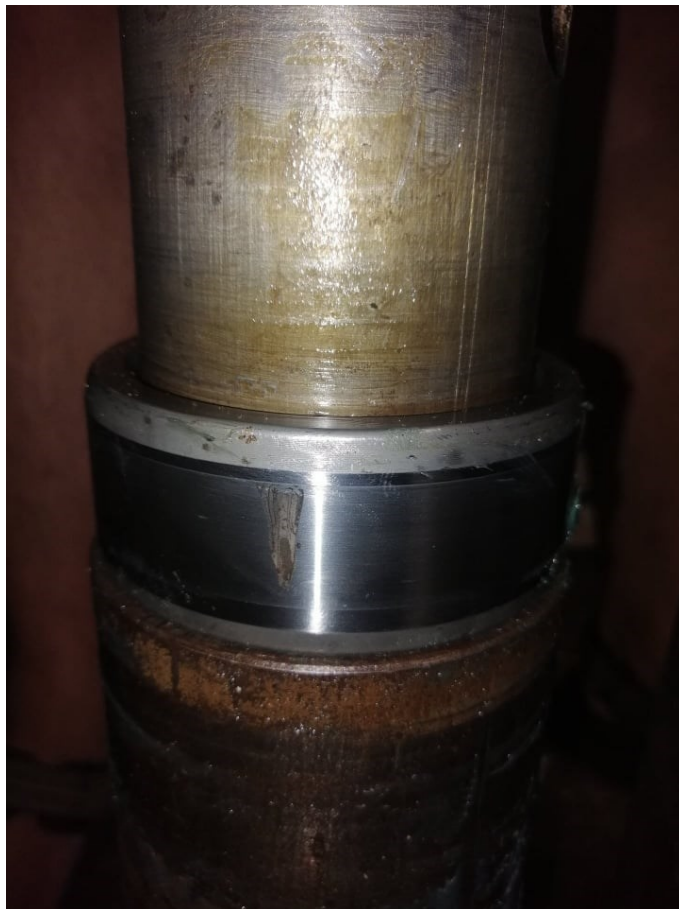
On the basis of the measurement results presented in Table 5., can be observed a drastic, 3-fold decrease in the value of the Peak parameter of the vibration acceleration envelope and also a significant decrease in the value of the AVG parameter. On the other hand, the statistical parameters of the velocity course increased, which is definitely an unfavourable situation, no less detailed inspection of the centrifuge and the belt transmission did not show any

Fig. 8. Bearing NU315 ECP / C3 with damaged outer ring

The appearance of a technological defect on the outer ring of the bearing, which is a friction pair with a housing, is not a typical damage for this type of machines and was an interesting problem to be described in this article. The consequence of the occurrence of bearing defects may be an increase in statistical values of the vibration signal and the appearance of new amplitudes in the FFT spectra. A vicious circle is created here, where bearings in poor dynamic condition increase the transmission of vibrations through the machine, and high vibrations accelerate

For the purpose of assessing the dynamic condition after replacing the NU315 ECP / C3 bearing, another diagnosis was performed in the bearing node No. 1 with the cage disassembled, and the results are also presented in Table 5 for comparison.

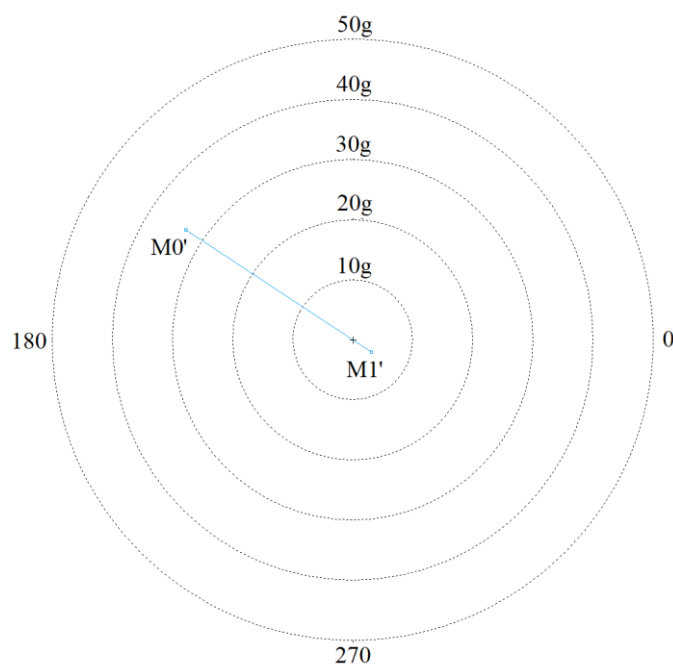
Fig. 10. Correction mass values for the second balancing

The residual mass w described in Table 6. - 3.14 g meets the requirements of the permissible residual weight of 8.03 g. The results of diagnostics of the bearing arrangement No. 1 after balancing are presented in Table 7.

After the basket was installed and the centrifuge was restored to its working condition, dynamic balancing was started. The visualization of the centrifuge with the basket installed during operation is presented in Fig. 9. Again, it was decided to perform a single-plane balancing in the radial direction Y in accordance with the sketch in Fig. 1. The balancing process is presented in Fig. 10 and in Table 6.

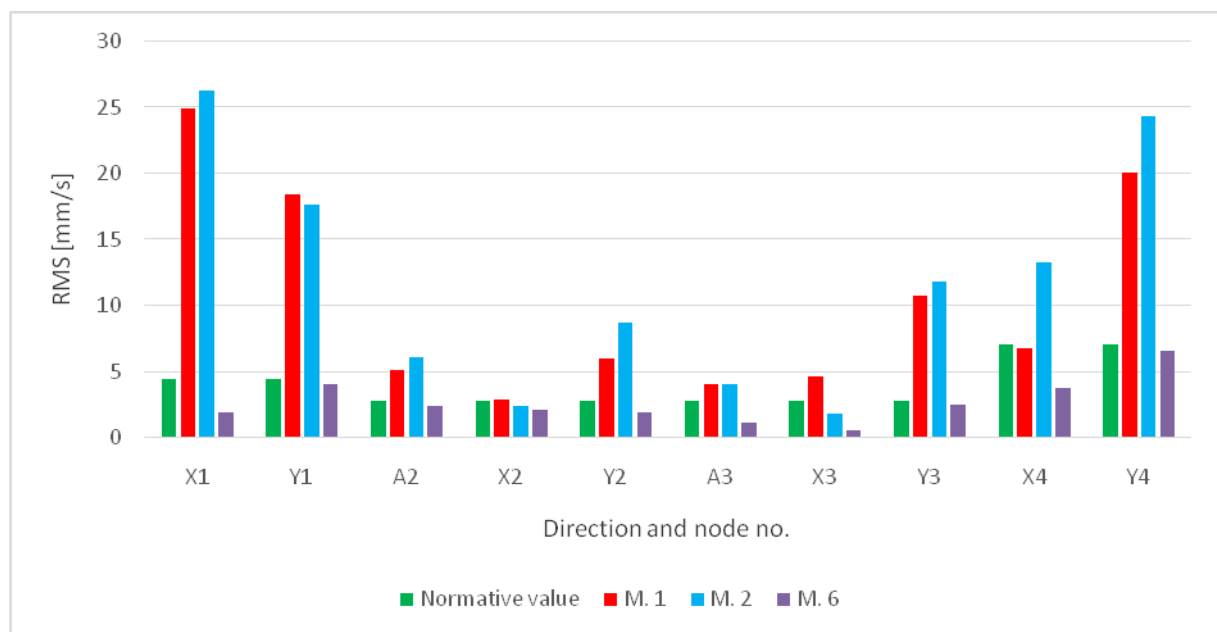
Fig. 11. Compare the normative values of RMS velocity with measured in measurements no. 1, 2 and 6

The diagnostic results described in Table 10. and Fig. 11. allow to classify the dynamic condition of the machine at a good level. As can be seen in the final results from table 9, the criterion of the balancing quality class has approximately been met.
